Technology 084: Foscomm Fiber Optic Perimeter Detection

The Foscomm Fiber Optic Perimeter Detection System, is a novel fiber optic perimeter detection system utilizing plastic fiber optic sensor technology to detect intrusion over outdoor fences. Foscomm's solution can be installed in parallel over existing fences and are both cut and bend sensitive. Physical perturbations such as bending, stretching, widening, or cutting caused by intruders are precisely detected, ignoring any environmental distortion.

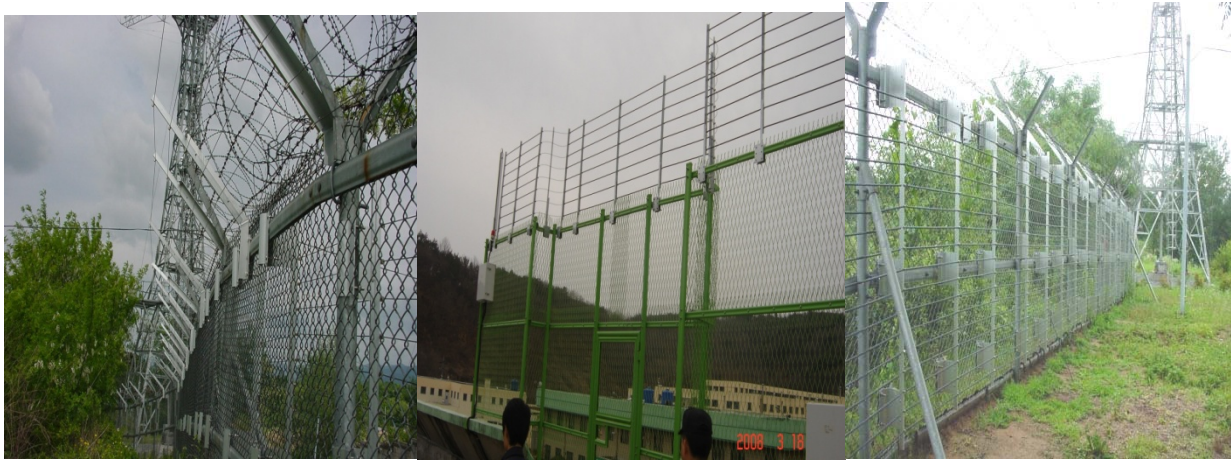
- ❖ Nuisance Alarm Rates (NAR)
- ❖ False Alarm Rates (FAR)
- ❖ Maintenance and Upkeep – Significantly reduced through the utilization of improved plastic optical cables which are easily repaired without the need for complicated fiber optic fusion splicing.
- ❖ Installation - The system is able to be deployed over the top of, and in conjunction with, existing systems alleviating the need for extensive reengineering.

On July 12th Sloan Security Group personnel commenced to testing the Foscomm Rayfort Fiber-Optic Based Security System located at the Sloan Security Group Facility at 6851 W. Targee St. Boise, ID, USA. The Foscomm system is installed as a 1m long outrigger structure on a 6' tall chain link fence that is approximately 3 years old. The fence is constructed of galvanized tubular posts (2 3/8" dia.) and top rail (1 5/8" dia.) in a heavy commercial-grade design. Also installed on the opposite side of this same chain link fencing is an 8' tall electrified intrusion detection system. The Foscomm System is installed on approximately 165 lineal feet of fencing and during this distance the fence turns two corners and changes from a 45 degree outrigger to a vertical outrigger.
